ASSESSMENT OF BUILDINGS AFTER GORKHA-EARTHQUAKE-2015: A CASE STUDY OF CENTRAL BUILDINGS OF KATHMANDU UNIVERSITY, NEPAL

Department of Civil and Geomatics Engineering, Kathmandu University

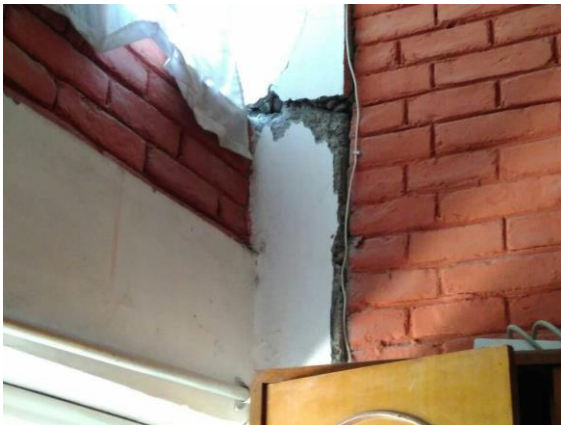
Figure 9: Short Column/Captive column Effect

Columns in Library block showed the captive column effect (Figure 9) due to the presence of partial height masonry walls. The brick masonry walls were built up to partial height. The height of the masonry walls being as tall as 648 cm. without any horizontal band, failed in many locations due to crushing and sliding. The walls are mainly found failing in plane in many locations while in the regions where pounding have occurred, the cladding bricks have failed out of plane.

Column and Beam cracks however requires special treatment. In the block number 3, also referred to as the Library block had several column cracks. The initial design underestimated the seismic load acting on the building which eventually caused the columns to crack. The sizes of column were not found to be sufficient, and hence required the increase of the column size, by the method of jacketing (Figure 17). Those columns which were found to be cracked were recommended for retrofit. The initial observation indicated that there were 26 columns urgently in need of retrofiting. It was also observed that the beams were unaffected by the lateral shaking, which further indicated that the building had strong beam and weak column, a deficient approach of design. Beam and slab cracks were recommended for epoxy grouting or cement grouting, depending upon the extent of the cracks. The beams which had more than 0.5 mm cracks were recommended for Fiber Reinforced Polymer wrapping.

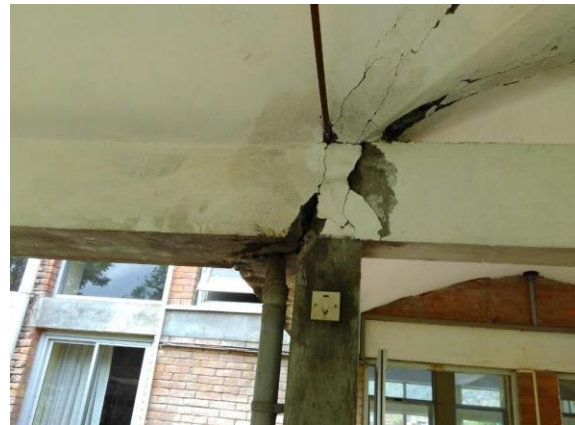
Figure 10: Pounding Effect

The library building was the most affected block due to this particular earthquake. The ground floor of the library was provided with wide spaces with no partition brick walls (Figure 5). This resulted in reduction of stiffness and eventually column cracks were observed. The building faced damages due to multiple deficiencies such as short column/captive column effect, soft storey, heavy mass on roof, pounding effect and slender columns. The Main administrative block (block 2) and the library block of different heights were connected by a passageway (Label 1 in the Figure 2), which was attached rigidly with the column on both the blocks. This resulted in hammering/pounding of the columns by the passageway beams, causing severe column cracks (Figure 10).

In the main campus area, the corridor portion between Block 2 and Block 3, located around the courtyard, was recommended for proper separation from the main structures, so that further pounding effect do not lead to cracks in column in the future earthquakes.

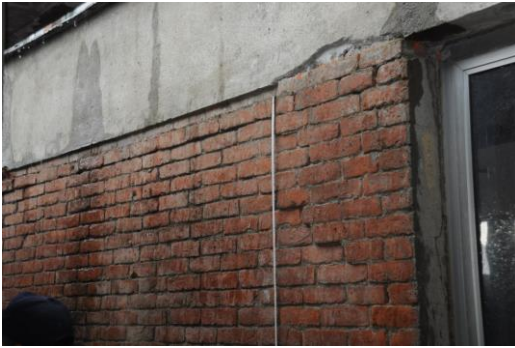
Figure 11: Out of Plane wall failure of cladding

During the earthquake motion, the reinforced concrete frame deformed first and cracks appeared on the plaster along the contact of infill wall with frame. When the deformation became bigger, it then separated the infill wall from the frame, resulting the cracking (diagonal or horizontal) of the wall. Further the pounding effect of the corridor in between Block 2 and library block (Block 3) caused the cladding wall to spall out of plane from its initial alignment. (Figure 11).

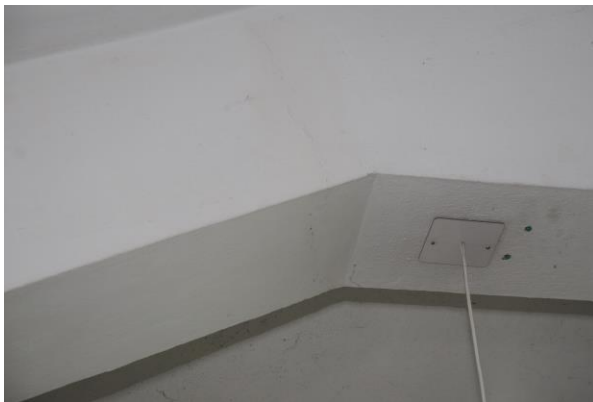
Figure 13: Cracks observed in inclined beam

The inclined beams present in the top floor of Block 2, showed minor vertical cracks near the bends (Figure 13). The building suffered numerous in plane wall cracks.

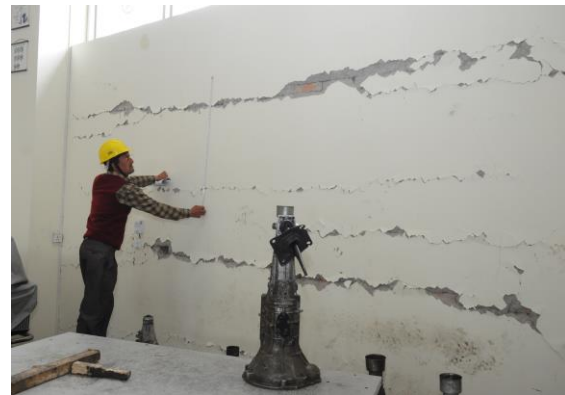
Figure 14: In plane wall cracks

The Technical Training Centre block (TTC) suffered numerous in plane wall cracks (Figure 14). Central columns, despite having long spacing without masonry infill wall between the columns (Figure 8), there was no major structural failure observed. The exterior infill walls cracked heavily. It was observed that the wall heights being too tall, the failure of infills occurred heavily. In blocks 6 and 11, horizontal wall cracks were observed. These structures were not 100 percent RCC framed structures therefore, the wall heights were about 648 cm high without presence of horizontal bands. The masonry walls however did not collapse. The Turbine Testing Lab (TTL), did not show any sign of distress and Girls' Hostel and Boys' Hostel, did not suffer significant damages. The Staff Quarter Block Building D suffered minor vertical beam cracks (Figure 12). Block 32 was found effected majorly in its top storey beams. Some minor cracks are observed in the top storey beams which need to be retrofitted.

Most of the buildings within the Kathmandu University premises suffered partition wall cracks. Cement plaster spall off was another main consequences of the earthquakes. However neither of these failures is considered major structural failures. These failures can be treated either by completely dismantling the walls or by using the wire mesh along with the cement grouting, depending upon the extent of the cracks (Figure 16). The figure 16 is an example of wire mesh strengthening with cement grouting in block 11.

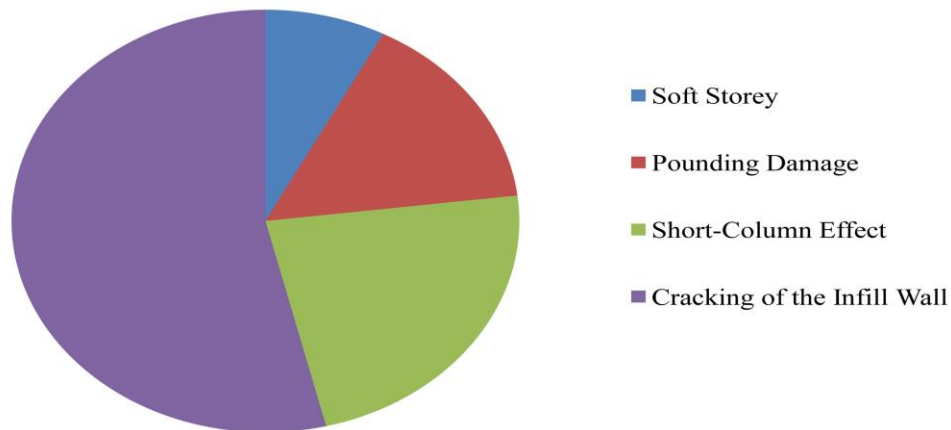
Figure 15: Failure pattern of the Buildings

Figure 15 shows the failure pattern of the Buildings, thus indicating majority of damages were due to soft storey, pounding effect, captive column effect and large height wall cracks.

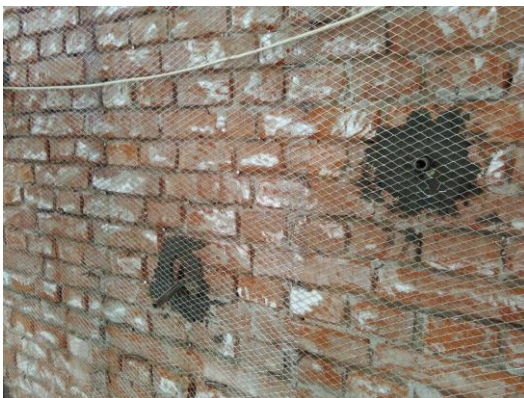
Figure 16: Retrofit of wall using wire mesh and cement grouting

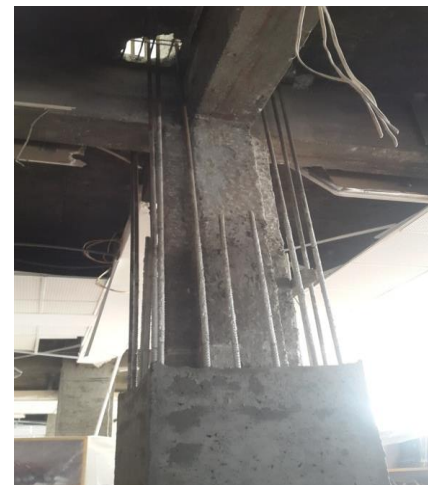
Figure 17: Retrofit of column by jacketing method.
