Assessing building typology and seismic vulnerability of masonry structures built with government grant after 2015 Gorkha earthquake

Neshil Koirala^a, Niraj Raj Panta^a, Prajwol Adhikari*^a, Achyut Paudel^b, and Manoj Sharma Wagle^c

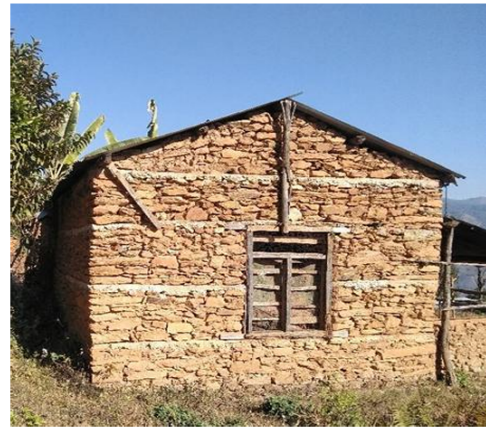
The inadequate thickness of reinforcement bands observed in the houses significantly enhances seismic vulnerability as shown in Fig. 7. This is further exacerbated by incorrect orientation of gable bands; they are most susceptible during seismic events. In addition, a missing Damp Proof Course (DPC) facilitates the travel of ground moisture into the superstructure as shown in Fig. 8. This migration

Figure 7: Improper band thickness and lack of gable band.

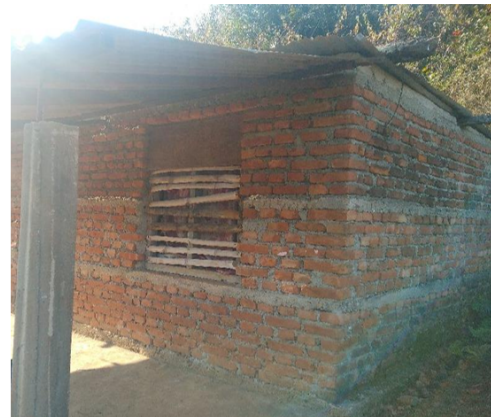
Figure 8: Inappropriate DPC results in mould formation.

of moisture leads to mold formation, which is not only harmful for the superstructure in losing its strength and integrity but is also ominous from a health perspective [14]. If mold can weaken building materials over time, it will lead to health concerns for people using that facility. That makes the correct method of construction and a proper moisture-control technique quite indispensable in its importance.

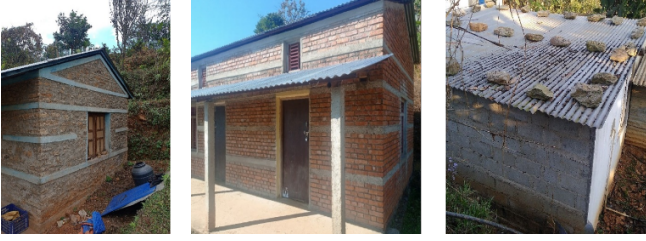
Figure 9: Surveyed houses of stone in cement, brick in cement and hollow concrete material.

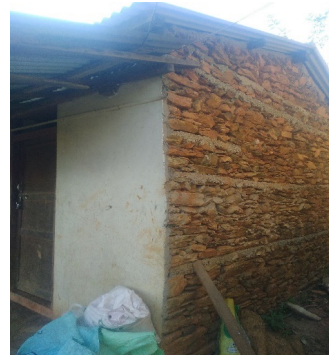
Figure 11: Poor roof to wall connection .
