A comprehensive review on structural behavior and mechanical performance of traditional timber joints in Patan durbar square

Abstract

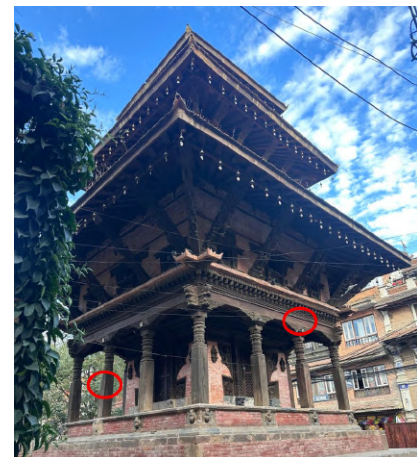
One of the most common joints between beams for lengthening or intersection is the Lapping joint. In the lengthening joint, a half lap joint is seen, whereas in the intersection at corners, a cross lapping joint is seen (See Fig. 2).

Figure 2: Temple at Swotha square with half lap joint on beam and finger joint on column

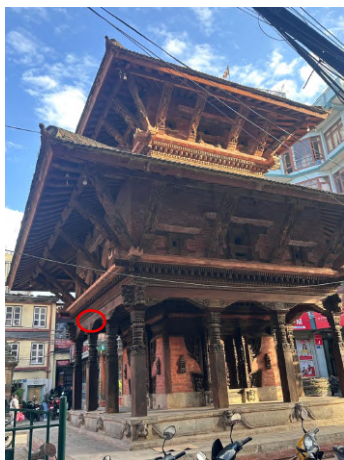
Figure 4: Mini Krishna temple with scarf joint

Scarf joints, especially stop-bladed scarf joints with pegs, are the most common type of joint seen for lengthening the beam (See Fig.

The joint appeared in the mini-Krishna Temple, just above the column for lengthening purposes. The key advantage of this joint type is that the peg effectively prevents slippage of the beam along its longitudinal axis. However, the presence of the cog cannot be reliably confirmed through non-destructive visual inspection. If the cog were absent, the peg would not be strictly necessary, as the joint could be assembled by sliding the beam in from the transverse direction. Based on these observations, the joint is most likely a stop-bladed scarf joint incorporating both a cog and a peg (See Fig. 5). Alternatively, the peg may have been included simply to compensate for irregularities or slight mismatches in the length of the joint. The total length of each joint appears to be approximately equal to the depth of the beam or slightly longer, with the insertion length being less than one-third of the beam depth.

Stop-bladed and stop-splayed scarf joints, often equipped with pegs, effectively prevent longitudinal slippage and maintain joint contact. Quantitative studies confirm that scarf joints typically retain 25–40% of the bending capacity of unjointed beams, depending on joint geometry and reinforcement [13, 14]. Stiffness degradation occurs early due to localized crushing and slip at contact surfaces, emphasizing that scarf joints act as deliberate structural weak points to maintain continuity rather than strength.

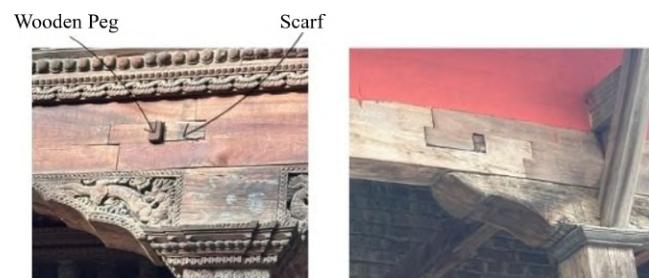
Figure 5: Stop bladed scarf joint with peg

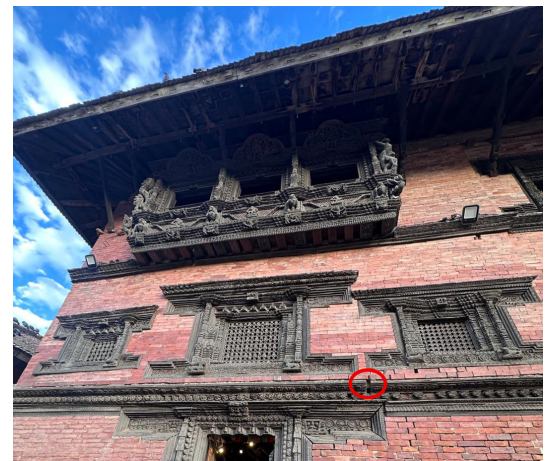
The joint is most common between the floors of load bearing structure, working as a band as well as a beam where the secondary beams of the floor are resting (See Fig. 8).

Although the joint appeared to be a simple butt joint, the presence of a mortise-tenon was revealed during movement of the joint during an earthquake. Tenon dimensions could not be measured, but movement patterns indicate that the joint provides partial rotational restraint. The existence of a wedge in the vertical direction could not be confirmed, and the length of the tenon could not be measured due to limited accessibility. These joints were commonly seen in the beam above the masonry of the building, and were rarely seen in the temples or monuments (See Fig. 9).

Figure 8: Mortise tenon joint appeared on the historic building of Patan durbar square

Mortise-tenon joints, frequently found above masonry, provide partial rotational restraint and exhibit semi-rigid behavior under lateral loading. Experimental studies indicate that traditional mortise-tenon joints display higher rotational stiffness at small deformations (15–35% of rigid connections) and exhibit energy dissipation under cyclic loading, with damping ratios of 10–20% [16, 19]. Such performance explains why structures employing these joints often show reduced seismic damage despite lower nominal strength.

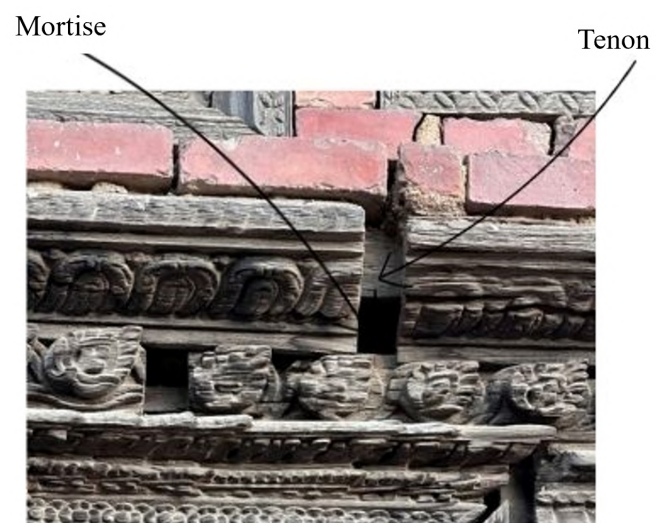
Figure 9: Mortise tenon joint

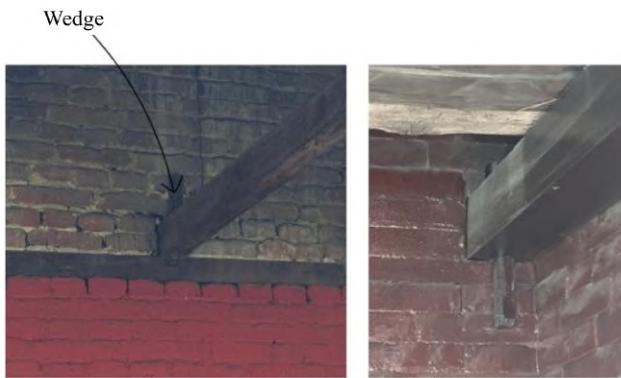
This joint type is found most commonly where the beams are resting on the masonry directly, but are not present when the beams are resting on a column, so mostly common on load-bearing structures (See Fig. 10).

A wedge was employed by inserting it into a hole made in the beam at the surface of the wall. This arrangement effectively prevents the beam from moving along its longitudinal axis, ensuring

Figure 10: Timber to masonry interface joint
