ASSESSMENT OF BUILDINGS AFTER GORKHA-EARTHQUAKE-2015: A CASE STUDY OF CENTRAL BUILDINGS OF KATHMANDU UNIVERSITY, NEPAL

Department of Civil and Geomatics Engineering, Kathmandu University

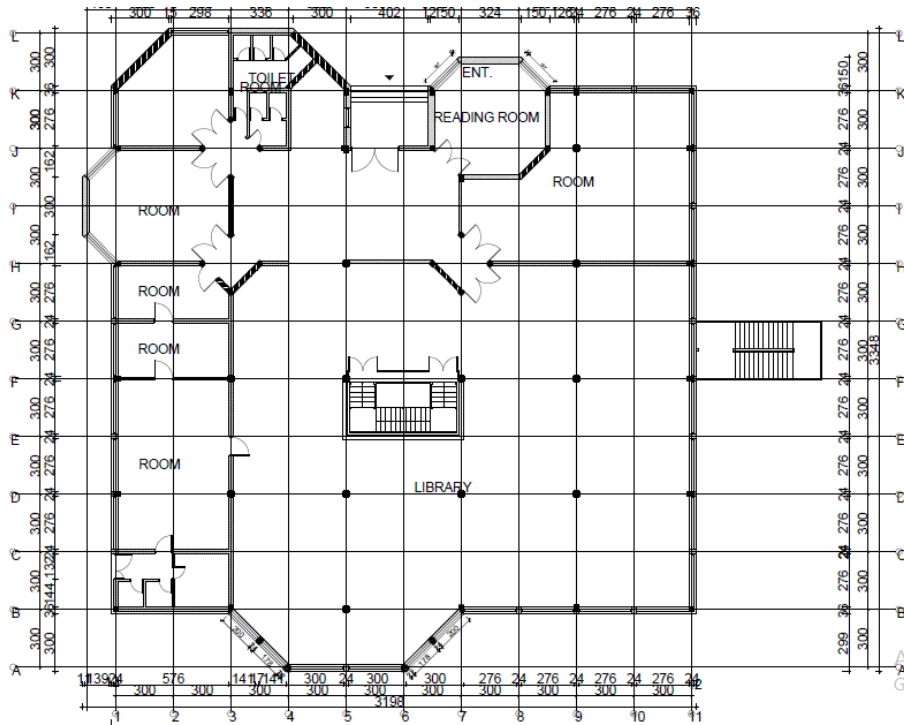
Figure 5: Block 3 Floor Plan

The library building was the most affected block due to this particular earthquake. The ground floor of the library was provided with wide spaces with no partition brick walls (Figure 5). This resulted in reduction of stiffness and eventually column cracks were observed. The building faced damages due to multiple deficiencies such as short column/captive column effect, soft storey, heavy mass on roof, pounding effect and slender columns. The Main administrative block (block 2) and the library block of different heights were connected by a passageway (Label 1 in the Figure 2), which was attached rigidly with the column on both the blocks. This resulted in hammering/pounding of the columns by the passageway beams, causing severe column cracks (Figure 10).

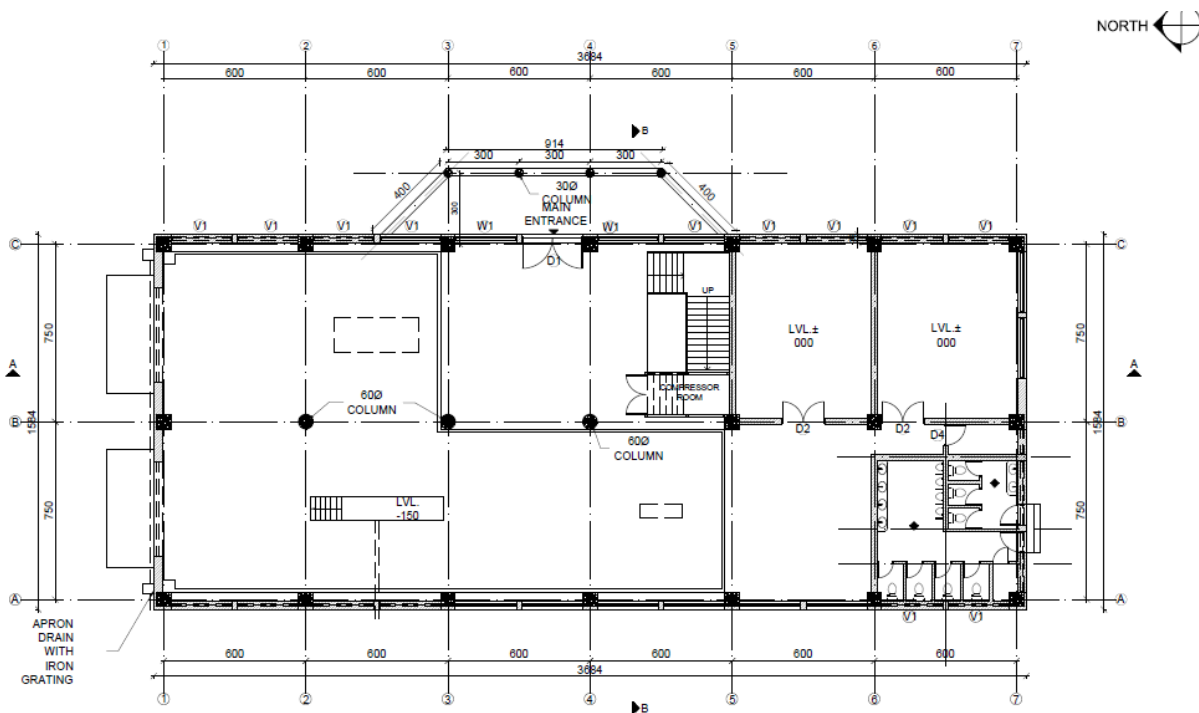
Figure 8: TTC floor Plan

The Technical Training Centre block (TTC) suffered numerous in plane wall cracks (Figure 14). Central columns, despite having long spacing without masonry infill wall between the columns (Figure 8), there was no major structural failure observed. The exterior infill walls cracked heavily. It was observed that the wall heights being too tall, the failure of infills occurred heavily. In blocks 6 and 11, horizontal wall cracks were observed. These structures were not 100 percent RCC framed structures therefore, the wall heights were about 648 cm high without presence of horizontal bands. The masonry walls however did not collapse. The Turbine Testing Lab (TTL), did not show any sign of distress and Girls' Hostel and Boys' Hostel, did not suffer significant damages. The Staff Quarter Block Building D suffered minor vertical beam cracks (Figure 12). Block 32 was found effected majorly in its top storey beams. Some minor cracks are observed in the top storey beams which need to be retrofitted.
