Assessing building typology and seismic vulnerability of masonry structures built with government grant after 2015 Gorkha earthquake

Neshil Koirala^a, Niraj Raj Panta^a, Prajwol Adhikari*^a, Achyut Paudel^b, and Manoj Sharma Wagle^c

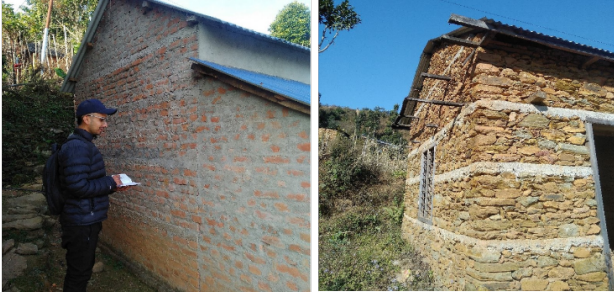
Figure 1: Typical buildings in Nalang village.

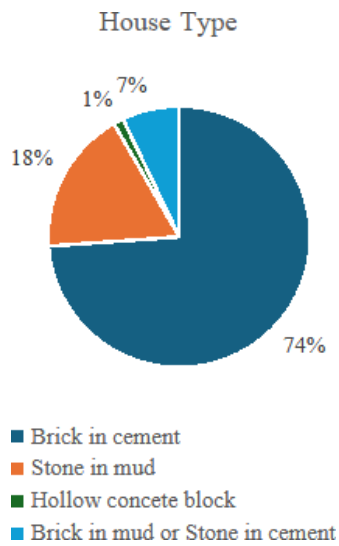
In the study, out of 909 reconstructed houses in the village [13], 325 houses were chosen for seismic vulnerability calculation. During the observation period, it was observed that 74% were brick in cement, 18% were stone in mud, 1% were hollow concrete block, and 7% were either brick in mud or stone in cement showing brick in masonry as most used material for construction as shown in Fig. 5.

Figure 5: Pi-Chart of building typology.

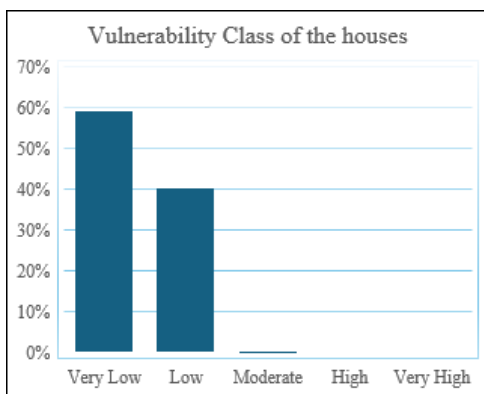
Among the 325 houses observed, as shown in Fig. 6, it was discovered that 41.5% exhibited a low vulnerability level, indicating significant risk factors such as structural weaknesses and inadequate disaster preparedness measures. Conversely, 58.2% of the houses demonstrated very low vulnerability, suggesting a higher level of preparedness for potential hazards, including better construction practices and adherence to safety standards. However, one house fell into the moderately vulnerable category, prompting concerns about critical vulnerabilities within the community. This particular house may have structural deficiencies or lack essential safety features, highlighting the need for immediate attention and remediation.

Figure 6: Classification of buildings according to their vulnerability class.

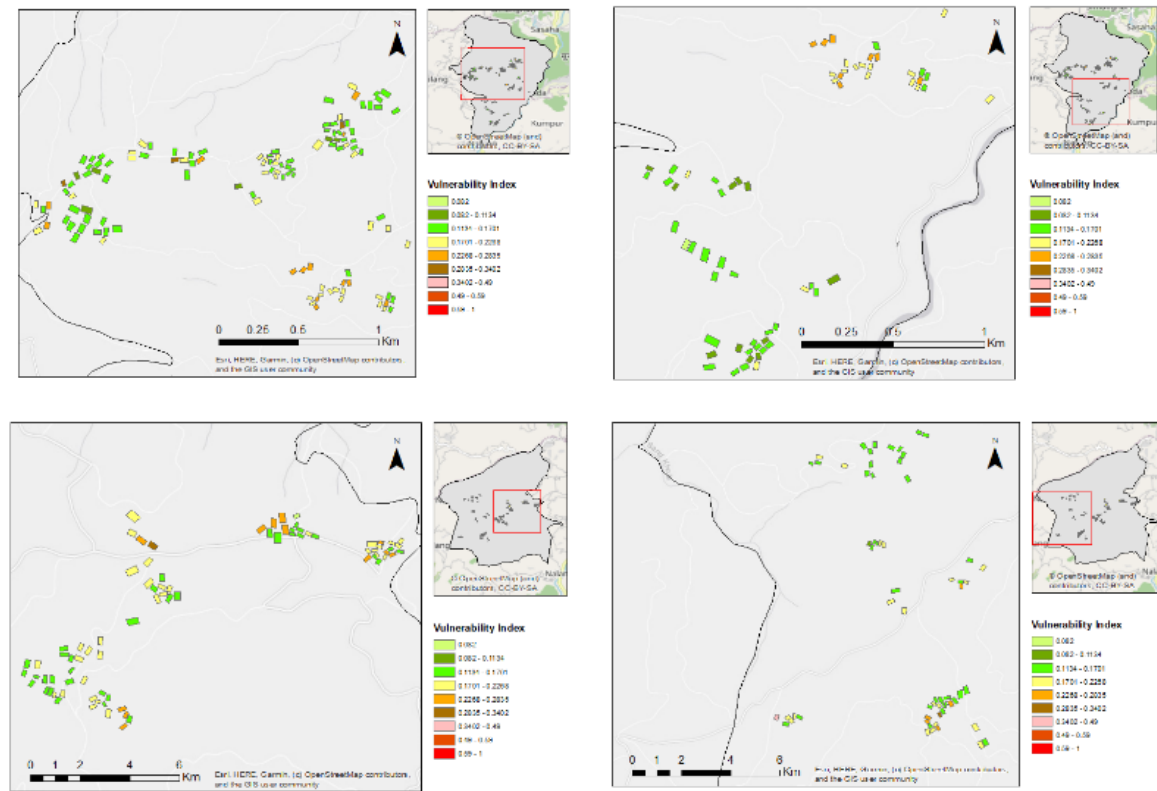
The vulnerability index map illustrates consistent vulnerability scores within specific areas but varies across different regions as shown in Fig. 12. This emphasizes the necessity for tailored interventions addressing the unique vulnerabilities in each locality. Houses marked in green indicate very low vulnerability, with three shades of light green representing intervals. Similarly, houses in

Figure 12: Seismic Vulnerability index map of Nalang Village.
